The effect of additives on boiler corrosion

Martin de Jong

DEKRA Solution, The Netherlands

The BECC Biomass CHP in the Netherlands

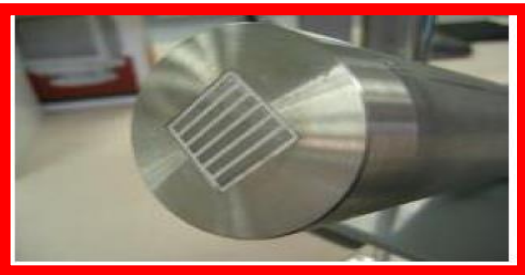
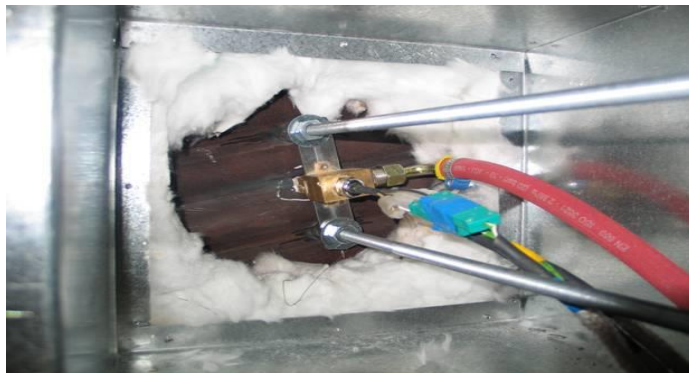
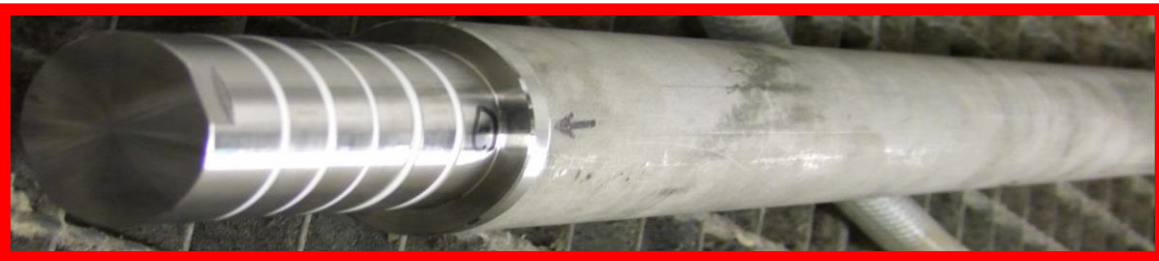
Probe overview

- Radiant Probes

- Superheater Probe

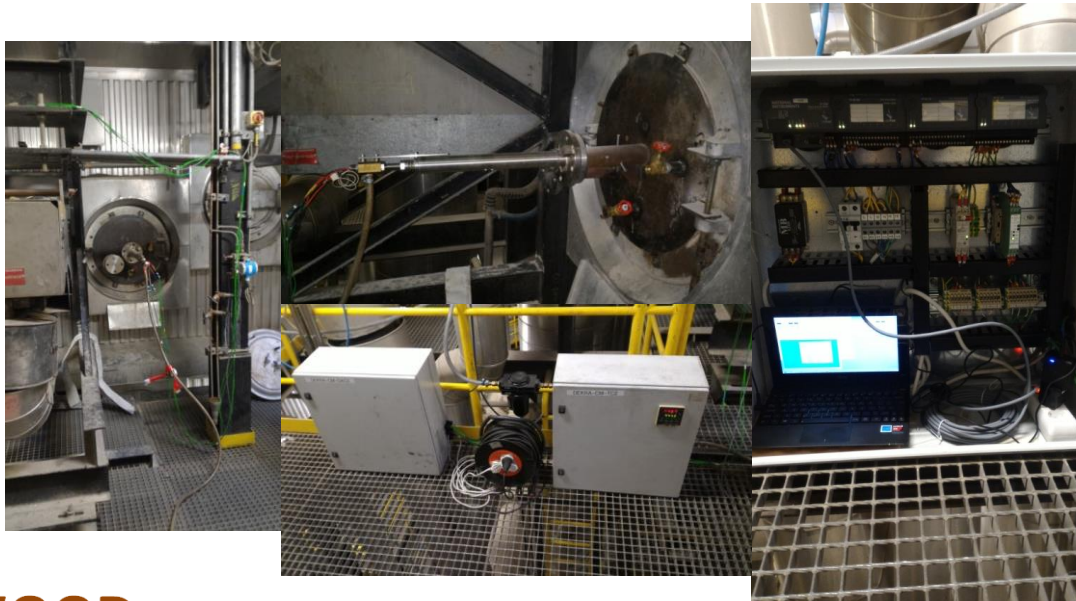
Corrosion and Fouling measurements in BECC (Cuijk) November 2016

- Preparations started in June/July 2016 by visiting BEC
- BECC prepared access port for superheater boiler section and economiser section; two ported acces for corrosion monitor and endoscope
- Two probes were constructed and 1 set of spare parts for a complete probe rebuild.
- Refurbishment of equipment, software update

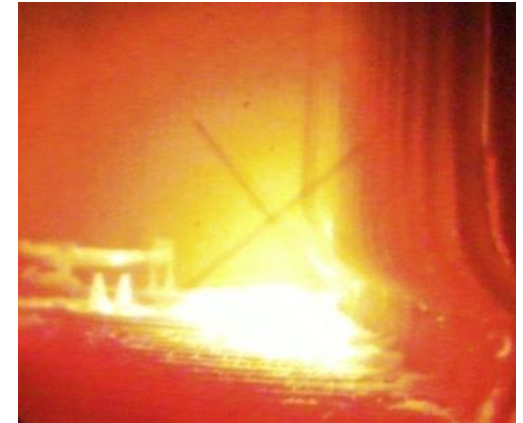
- The corrosion/fouling monitoring system was successfully installed beginning of November 2016 at the BECC
- Problems occurred prior to biweekly blasting --> The deposit built up on the probe made it impossible to retract it without force
- Probe survived the heavy beating with a hammer, but the access port needed to be modified (larger diameter).
- Half November 2016 an endoscope was tested and is standby on site

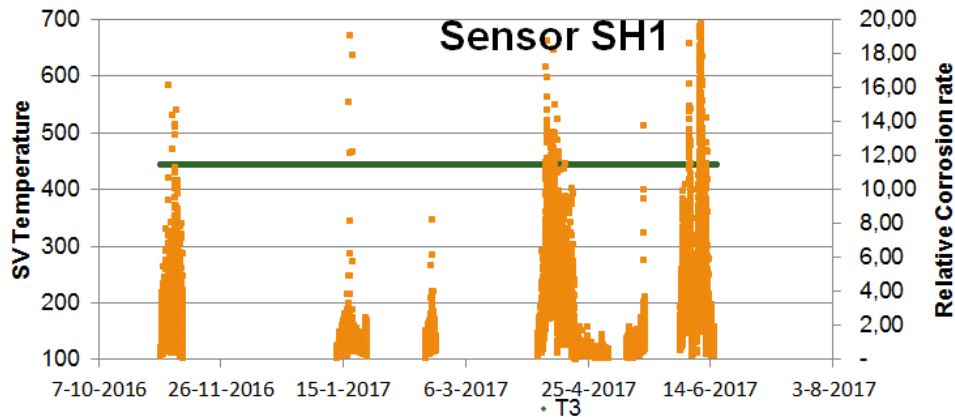
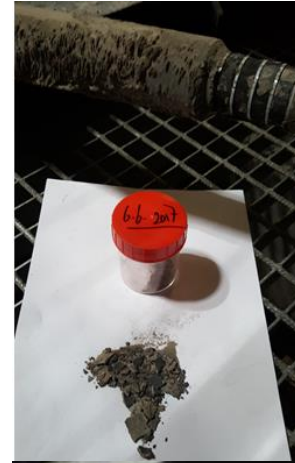
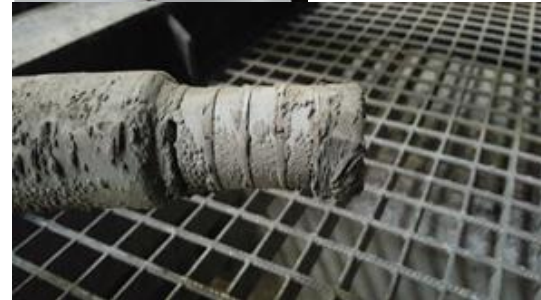
First findings

- Unfortunately plant operation during the trials was too unstable to generate reliable measurements for the campaign (partload, dosing problems/limitations and temporarily boiler of line due to sand bed pollution. Therefore the measurements are less representative to determine the influence of fuel/additive mixtures on corrosion and fouling.
